Manhole Inspection Summary

Manhole # S11II_049MH

Location Address: **1721 LONGWOOD ST**

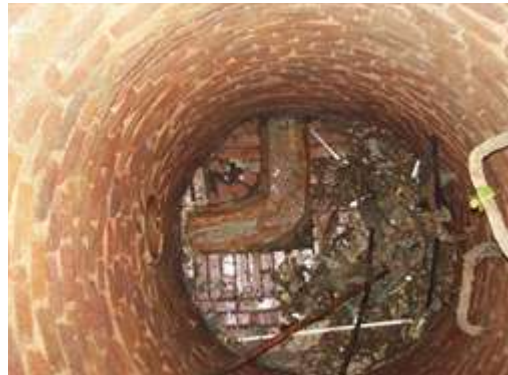
Top View

Condition: ☐ Sound ☐ Cracked ☐ Root Intrusion ☐ Deteriorated ☐ Leaks ☒ **Debris**

Steps Count: **5** Missing: **0** ☒ **Corroded**

CORRODED STEPS AND DEBRIS ON
BENCH AND IN CHANNEL

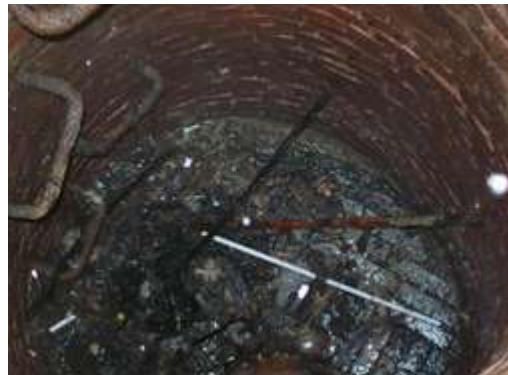
Defect 2

CORRODED STEPS AND DEBRIS ON
BENCH AND IN CHANNEL

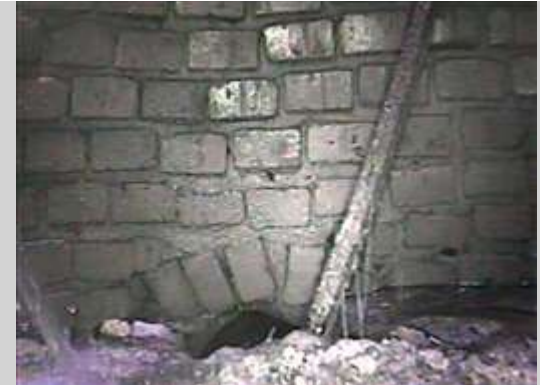
12 O'Clock Outflow

8 in. Circular Gravity Sewer
Pipe Out @ 12 O'Clock

Pipe Height: (in.) Direct
Pipe Material: **Clay** ☐ Pipe Lined
Invert Depth: **9.68** (ft.) Flow Characteristics: **Slow**
Deposits: ☐ None ☒ Mud ☒ Sludge ☒ Debris ☒ Grease
Silt Depth: **7** (in.) Deposits Extent: **Heavy**
Infiltration: **None** Pipe Seal Cond: **Unknown**

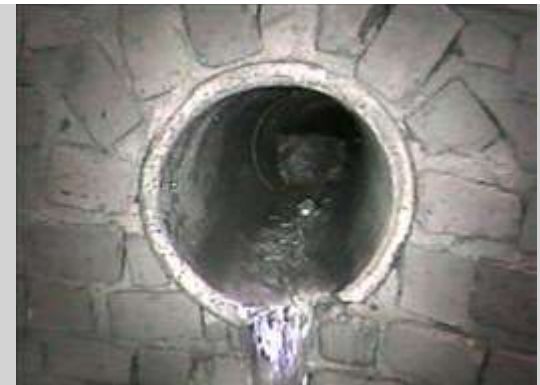
9 O'Clock Inflow

8 in. Circular Gravity Sewer
Pipe In @ 9 O'Clock

Drop In @ 9 O'Clock

Pipe Height: (in.) Direct
Pipe Material: **Clay** ☐ Pipe Lined
Invert Depth: **7.15** (ft.) Flow Characteristics: **Slow**
Deposits: ☒ None ☐ Mud ☐ Sludge ☐ Debris ☐ Grease
Silt Depth: **7** (in.) Deposits Extent: **Heavy**
Infiltration: **None** Pipe Seal Cond: **Cracked**

Drop: **Inside** **Direct**
Angled: Reading: (ft.)
Inv Depth: **10.20** (ft.)
